TECHNICAL NOTE 2039

INVESTIGATION OF FRETTING CORROSION

BY MICROSCOPIC OBSERVATION

By Douglas Godfrey

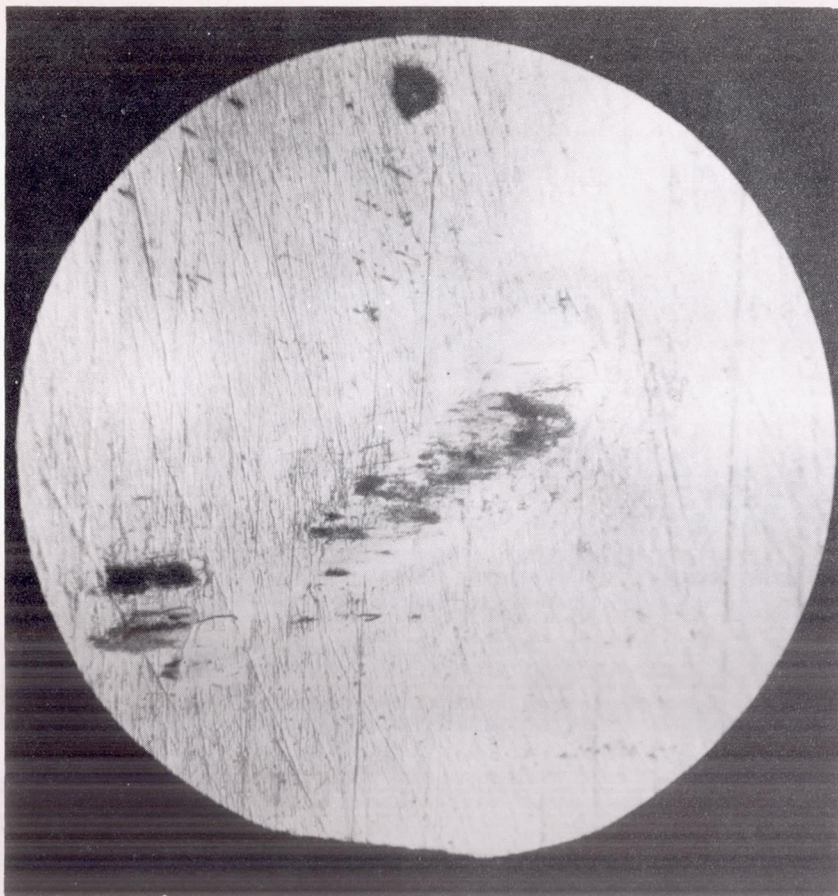
Other metals vibrated against glass slides supported the explanation of fretting corrosion deduced from the steel-glass experiments. In one experiment, flame-cleaned platinum foil supported by a steel ball was vibrated in contact with clean glass. The generation of a black powder in the characteristic way was observed (fig. 6). This powder remained black and that which

adhered to the glass could be completely removed only by a 4-hour treatment in aqua regia. Color, acid resistance, and source indicate that the material was finely divided platinum (platinum black). Because platinum will not oxidize in air at any temperature, the theory that oxidation is the primary action of fretting corrosion is not supported.

Figure 6. - Photomicrographs of convex platinum surface through glass slide showing wear and debris produced. X140.

(c) Debris accumulation outside field of view of figure 6(b).

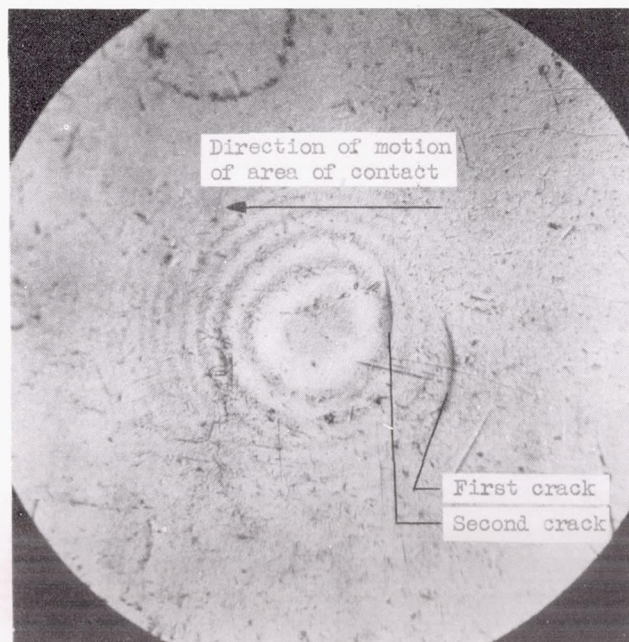
(b) View of ball through glass showing second crack being formed in glass on trailing edge of area of contact.

Figure 7. - Photomicrographs showing effects of one-half cycle vibration between glass and steel surface. X140.

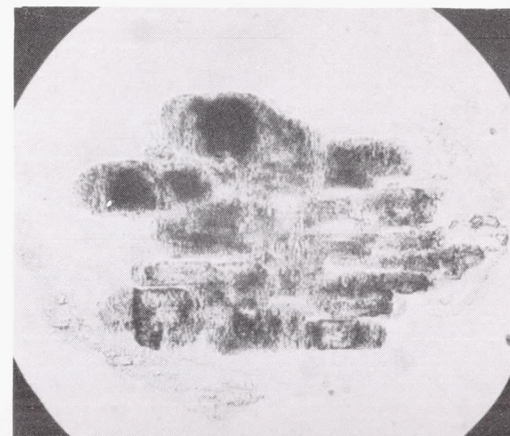
The independence of fretting corrosion from chemical action was indicated in a group of experiments involving the nonmetallic, nonoxidizing materials glass against quartz, ruby, or mica. By vibrating a ruby with a convex surface against a glass slide and observing the action under a microscope, surface disintegration could be seen to occur. The glass, after 2 to 3 seconds of rubbing, suddenly collapsed locally and distributed debris about the contact area, leaving a pit. This action shifted the bearing area to the edge of the pit and the disintegration was continued (fig. 8). An early stage of disintegration with two pits formed is shown in figure 8(a) whereas the advanced stage of 20 or more pits is shown in figure 8(b). The ruby was simply further polished, that is, the microscopic scratches were erased. The vibration was not continued long enough to pit the ruby. Quartz against glass acted the same as ruby against glass. Mica against a glass ball and Lucite against a glass ball also behaved similarly. In all cases, the debris was produced, extruded, and accumulated in the same manner observed with metal debris, except that no change in color took place. Fretting corrosion occurred to mica in the least number of cycles, the number required being progressively greater for Lucite, glass, quartz, and ruby, which is also the order of increasing hardness of the

Figure 8. - Photomicrographs showing results of fretting corrosion between ruby and glass. X140.
